CARMU Inspection Report 01/2023
Contractor: Nauru Ocean Resources Inc.
Doc.No: INSP/2023/NRU/001
Inspection: June 2022 - January 2023

Document origin	CARMU, ISA Secretariat
Version	Version 1
Document number	CARMU Inspection report 01/2023
Date approved for released	20 February 2023
Web publication	21 February 2023

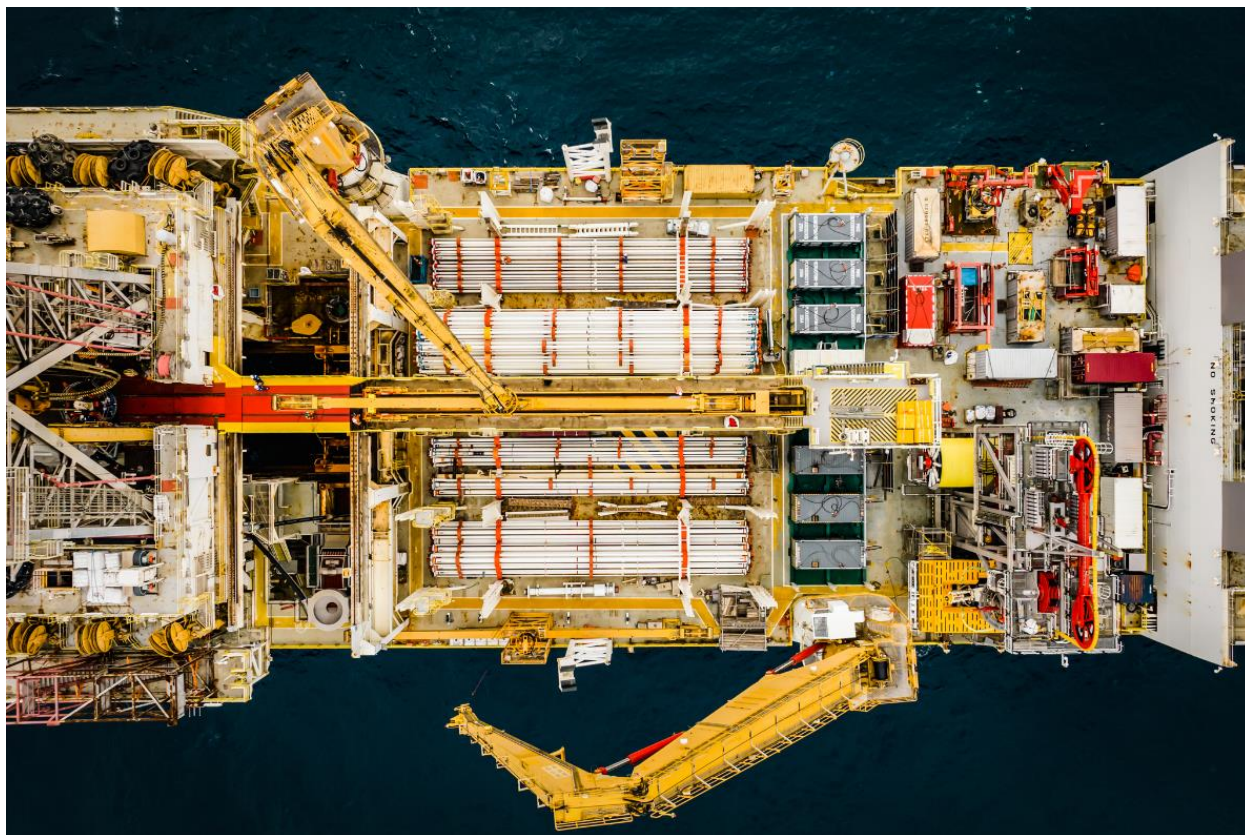
Photos 7: Riser deck on the *Hidden Gem* (source: NORI)

79. It was noted that there was no redundancy for the subsea umbilical onboard. The subsea umbilical is a bundle of cables and conduits that transfer hydraulic and electric power from topsides to subsea. The lack of redundancy was justified by the fact that this was a pilot campaign, and it was not cost effective to have a spare umbilical on the campaign.

80. However, during actual mining, a spare umbilical will be available to reduce non-productive time (NPT). A destructive test (at 170 tons) had been carried out on the umbilical to assess its integrity.

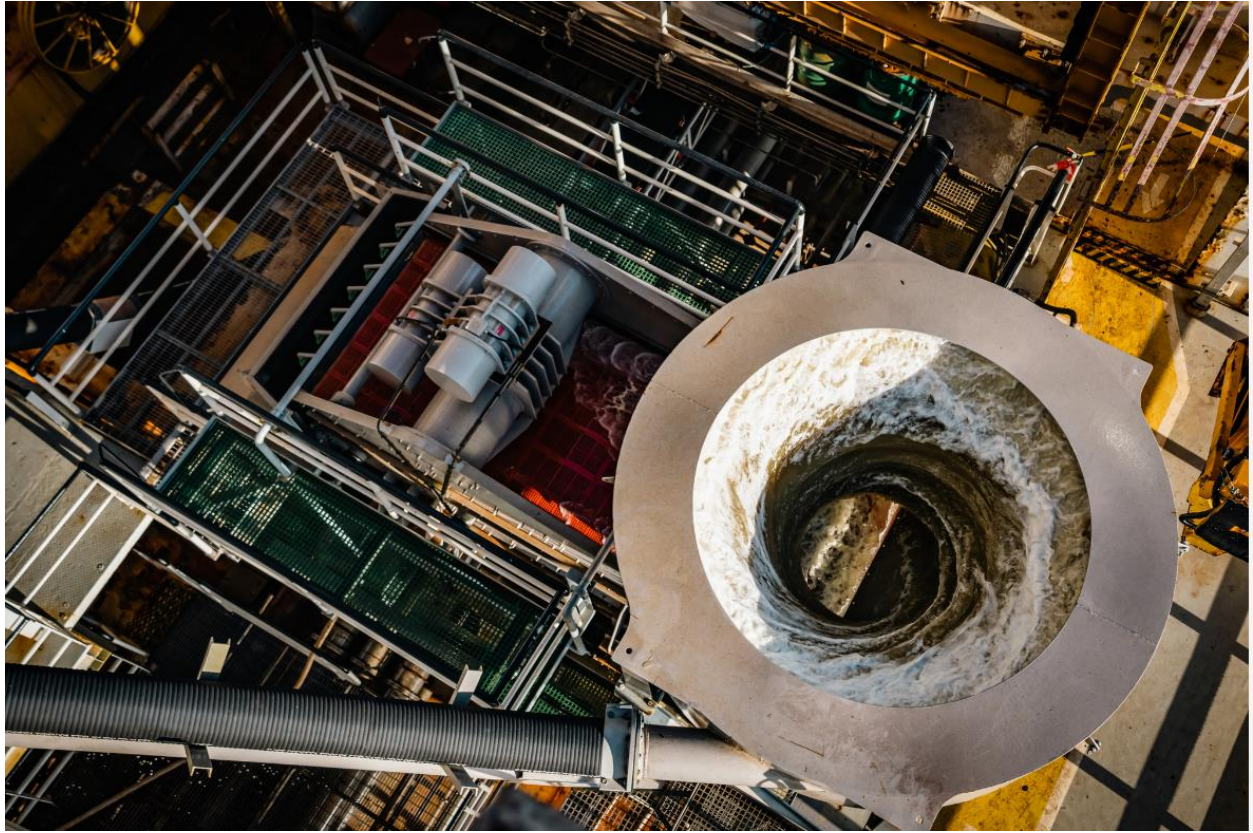
96. The Contractor's estimate on 18 November 2022 was that between 48-72 cubic meters of seawater with a sediment concentration of approximately 5kg per 100 litres went overboard during the event, which occurred intermittently during a production test run over a period of 8 hours.

Photo 14: Event site with cyclone and shaker (source: NORI)

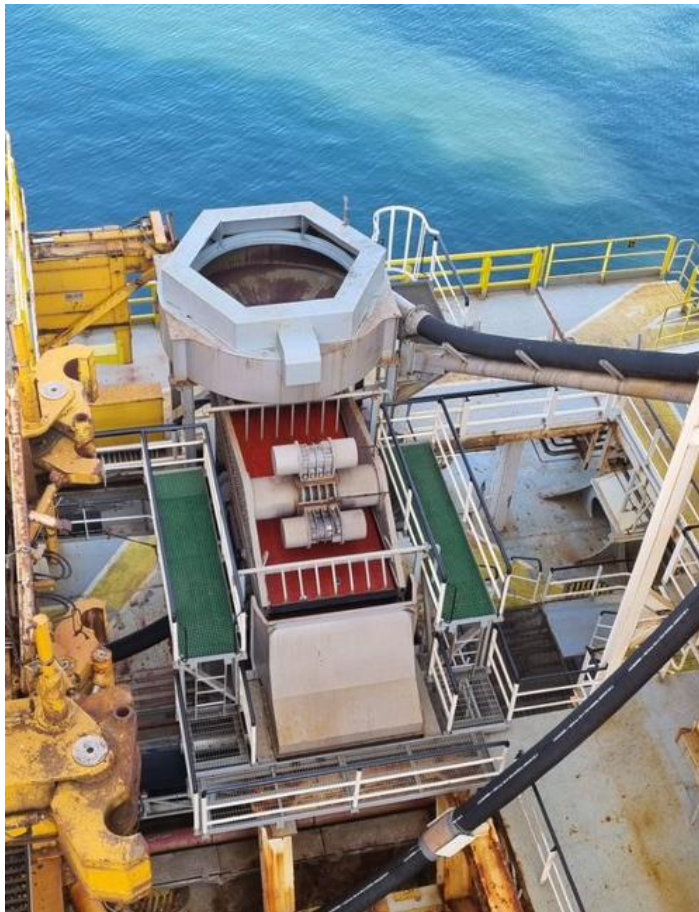
Photo 15: Event site with cyclone and shaker (source: ISA Secretariat)

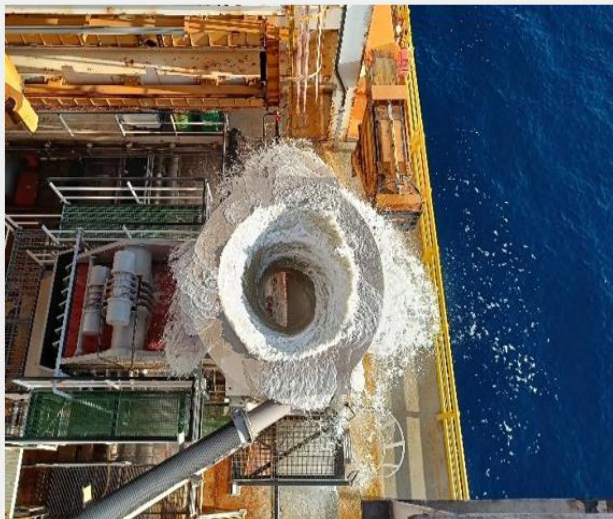
During the execution of the Pilot Mining test (production ramp-up test STR1.2), on the 12th of October in the Nori D field.
Cause: unexpected dynamic behaviour of the airlift riser, the system experienced intermittent surges in the volume of the slurry flow. These surges exceeded the designed buffer capacity of the cyclone feeding the separator deck. As a result, the cyclone experienced intermittent overflows of processing water containing sediment and fragments of nodules.

Cyclone feeder during overflow event – top view

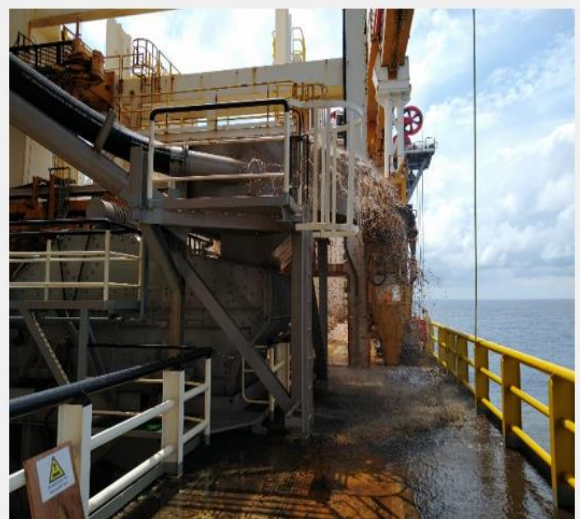
Cyclone feeder during overflow event – side view

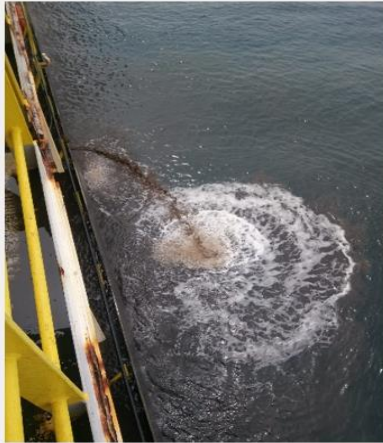
The overflow was discharged onto the deck of the vessel and eventually over the side to the surface waters. This unplanned discharge did not contain any hazardous substances and was limited in volume (<5% of the total flow). The intermittent overflow was observed periodically for the duration of the 8-hour test run that was being conducted at the time. The volume of unplanned discharge to the surface waters was calculated to be 100-150 litres/min, containing ~5kg per 100liter (equating to the disposal of the residual sediment from 1-2 sampling box cores per hour).

Discharge over the side of the vessel

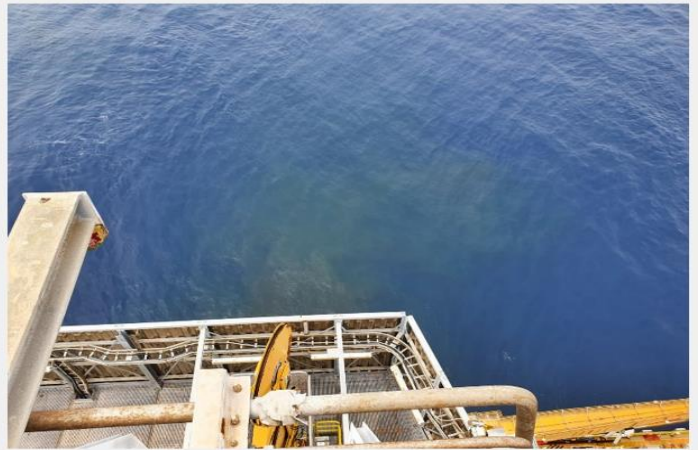
Discharge plume photograph taken from the derrick tower +100m from sea level

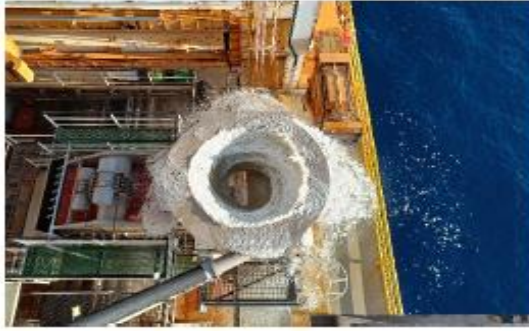
The overflow was discharged onto the deck of the Hidden Gem and eventually over the side to the surface waters. (see Figure 2, 3 and 4). The intermittent overflow was observed periodically for the duration of the 8-hour test run that was being conducted at the time. Photographs were taken during and after the event to ensure a record of the overflow.

Figure 2: Cyclone feeder during overflow event – top view

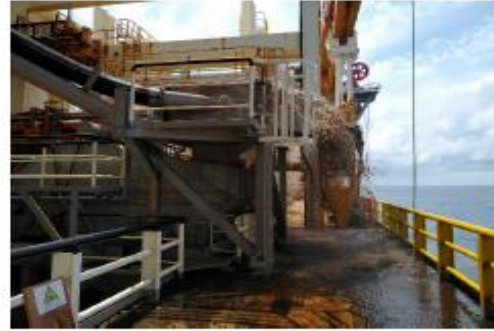
Figure 3: Cyclone feeder during overflow event – side view

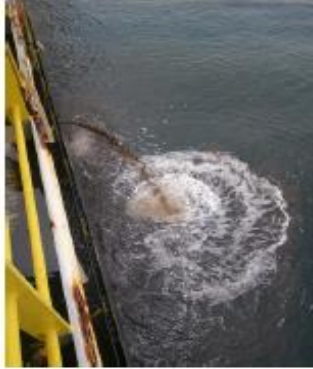
Figure 4: Discharge over the side of the vessel

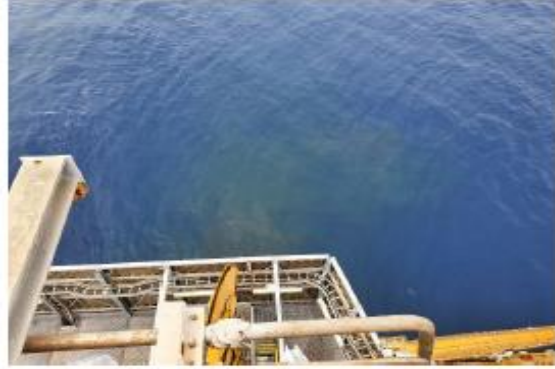
The discharge was observed visually and it was noted that the surface waters appearance returned to normal conditions in less than one hour after the event.

Figure 5: Discharge photograph taken from the derrick tower +100m from sea level
